PHOTOGRAPHIC INTELLIGENCE REPORT

STORAGE DEPOTS NEAR
SAN-SHIH-LI-PAO, CHINA

CIA/PIR 63043

DATE APRIL 1966

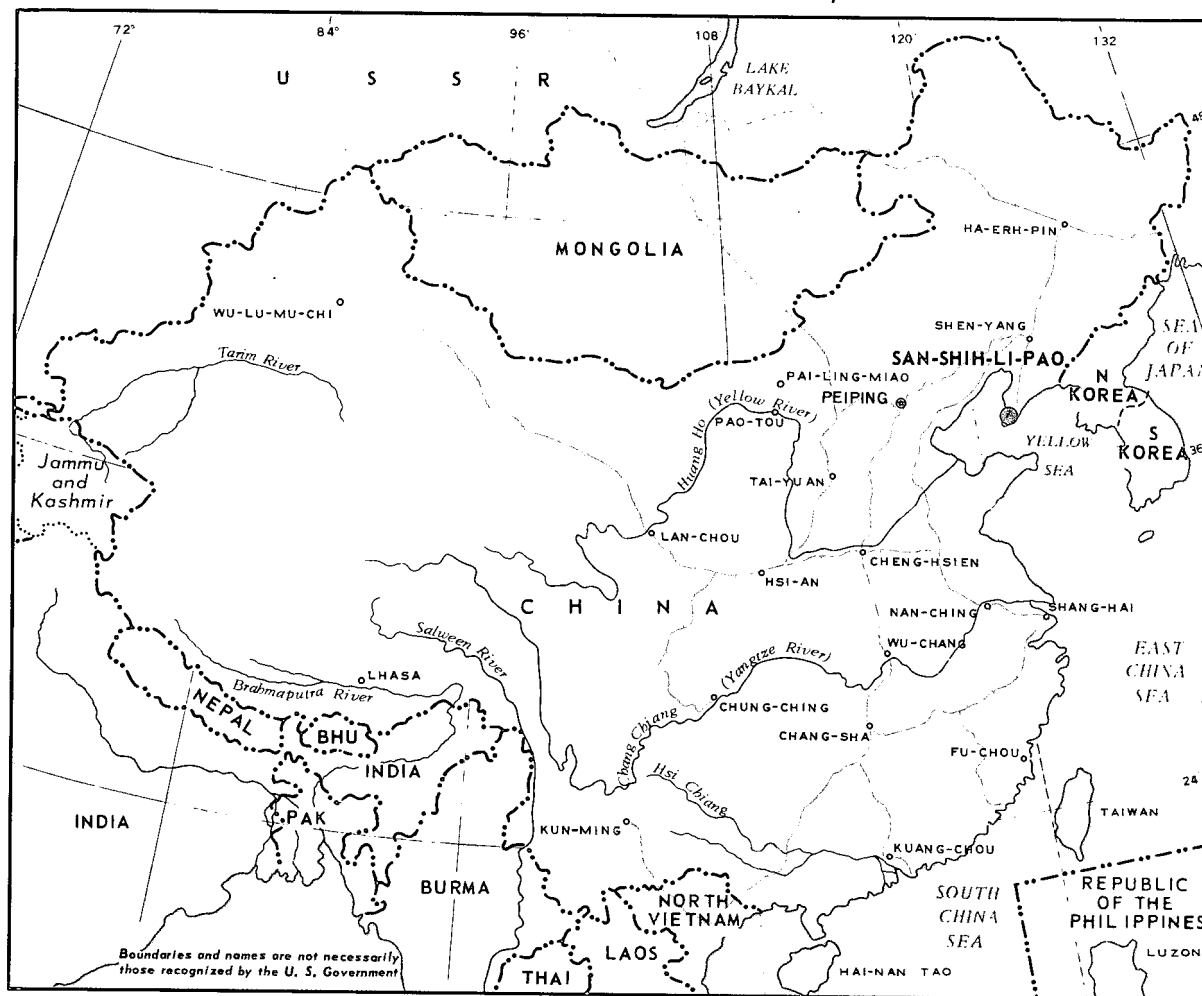
FIGURE 1.

Two previously identified storage depots are collocated at 39-00N 121-38E, 2 nautical miles (nm) east of San-shih-li-pao, China (Figure 1). The depots are separately secured and are not directly connected by roads. Storage buildings at the depots are of distinctly different design (Figure 4). For this reason, each depot will be discussed separately in this report.

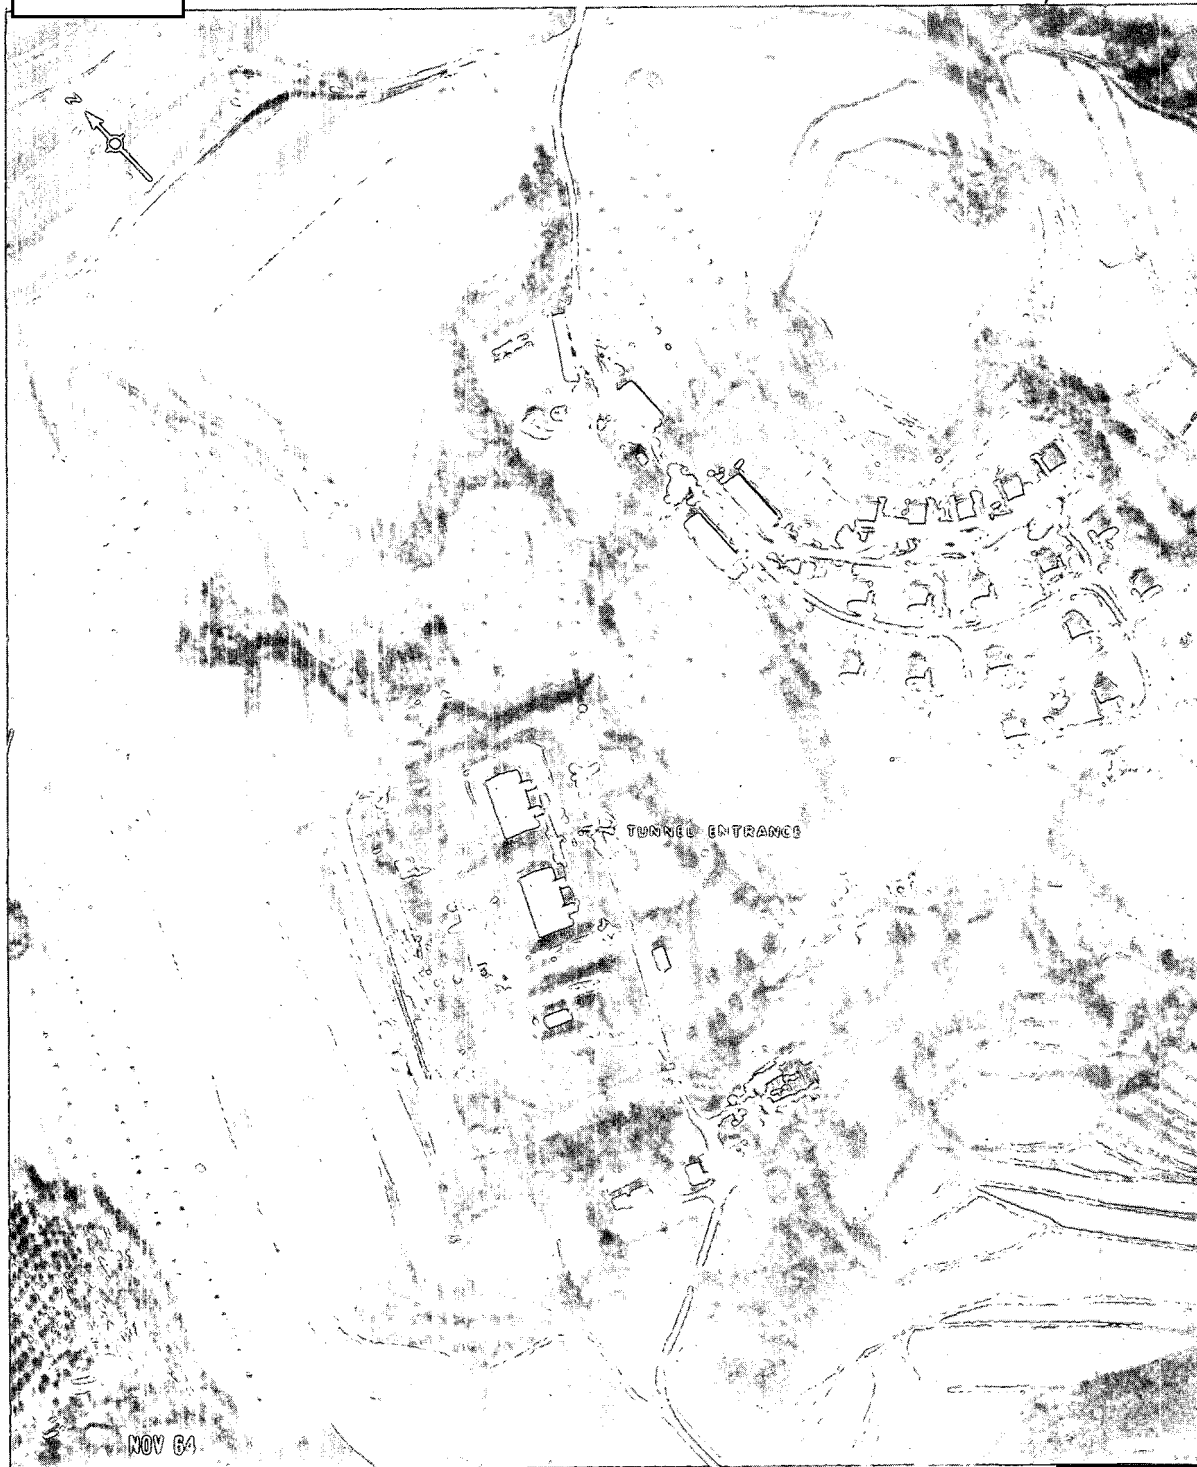
FIGURE 2. STORAGE DEPOTS NEAR SAN-SHIH-LI-PAO, CHINA.

Facilities in the storage area include 3 gable-roofed storage buildings, 1 buried tank, and a service/support building. The 2 large storage buildings (Items 1 & 2, Figure 3) are surrounded by a high, rectangular revetment which provides blast protection and also isolates them from the smaller storage building (Item 3, Figure 3). The small storage building is also heavily revetted. Each of the 2 large buildings has 6 stack-type ventilators on its roof. Two covered entrances are located on the east side of each of these buildings. A narrow tunnel through the revetment provides access to the buildings (Figures 2 & 4).

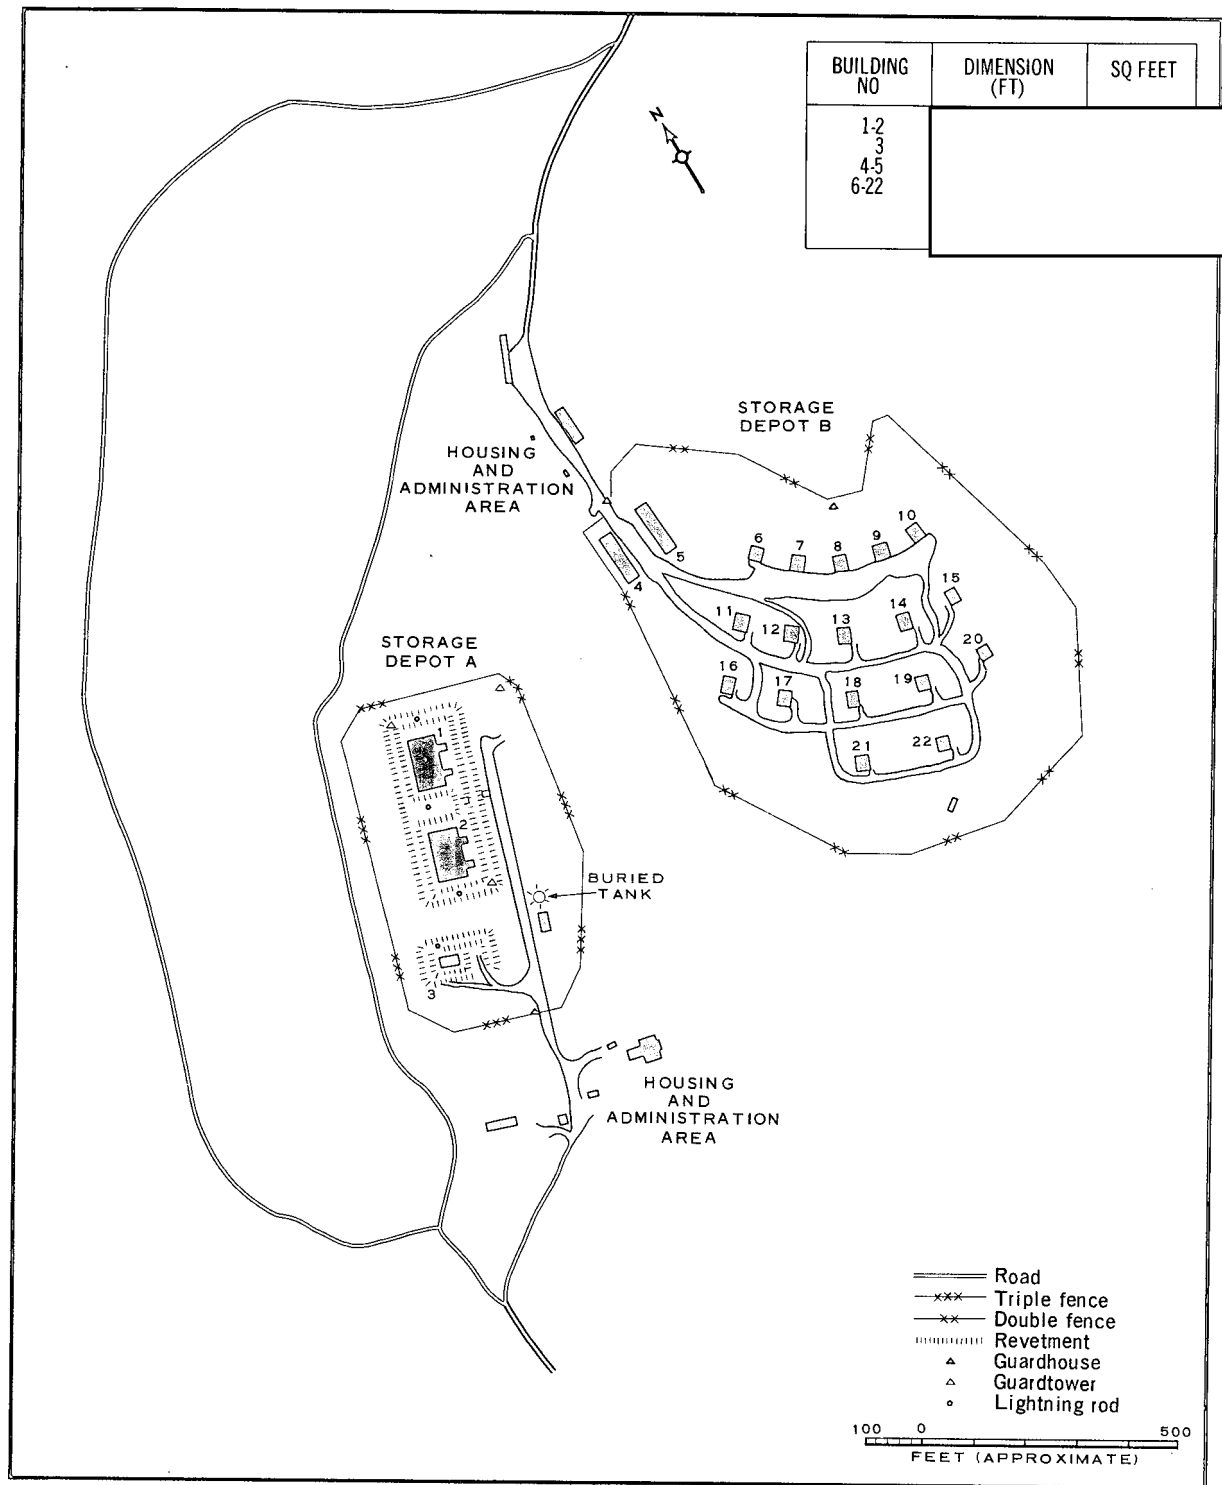
FIGURE 3. STORAGE DEPOTS NEAR SAN-SHIH-LI-PAO, CHINA.

The entire storage area is surrounded by a triple fence. A small guardhouse is located at the entrance, and 3 guard towers are observed at the locations indicated in Figure 3. A probable patrol path, which connects 2 of the guard towers, can be seen along the top of the revetment which surrounds the 2 large buildings.

The 2 gable-roofed warehouses (Buildings 4 & 5, Figure 3) probably serve as receiving and shipping points for the items stored in the storage buildings.

The storage facilities are secured by a double fence. Guardhouses are located at the entrance and also in the northern part of the storage area near the fence line (Figure 3).

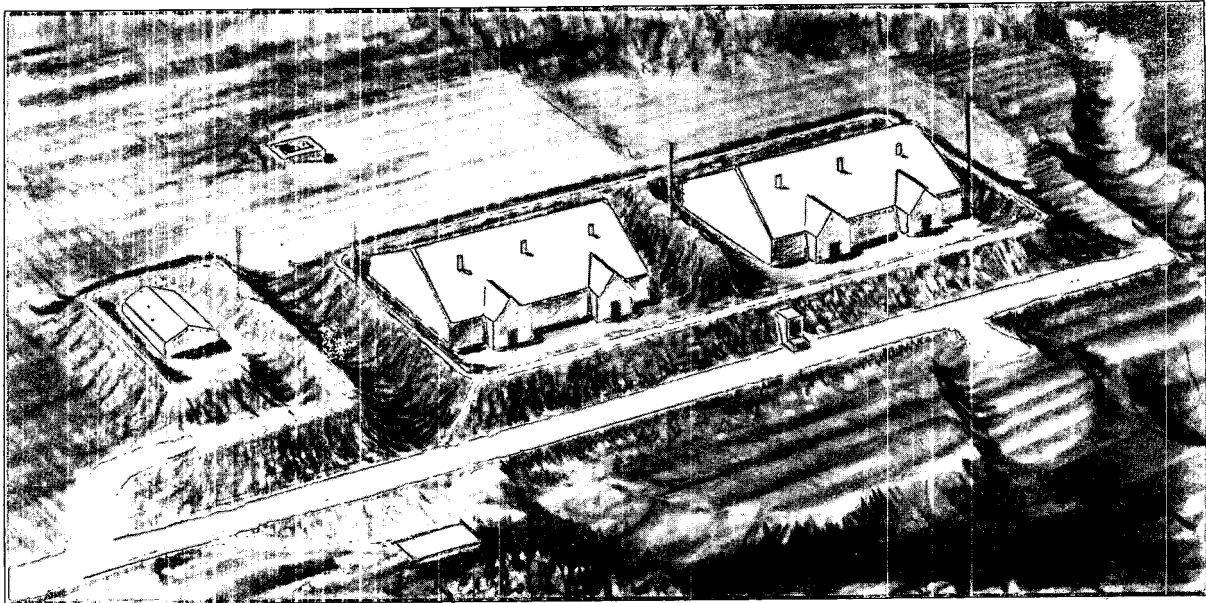
FIGURE 4

PERSPECTIVE VIEW, STORAGE BUILDINGS AT DEPOT A.

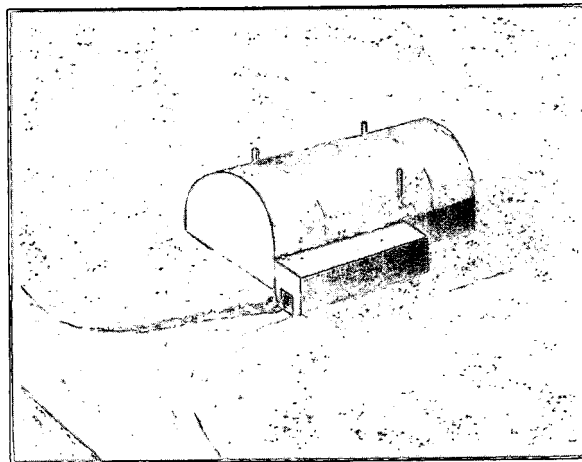
Facilities in the storage area include 17 arch-roofed storage buildings, 2 gable-roofed warehouses, and a small service building. The arch-roofed buildings appear to have been constructed in shallow excavations leaving the floor level slightly below the adjacent ground level. A covered entryway is located along the side of each of the storage buildings (Figure 4). Three stack-type roof ventilators are visible on each of the 17 arch-roofed storage buildings as indicated in Figure 4.

PERSPECTIVE VIEW, STORAGE BUILDING AT DEPOT B.
